Chapter 5

The *Tu Giac* Prototype Applications and Conclusions

5.1 An Example of Applying *Tu Giac* Conservation Prototype on Similar Buildings in Similar Climate: A Case Study of Wat-Ket houses, Chiang Mai, Thailand

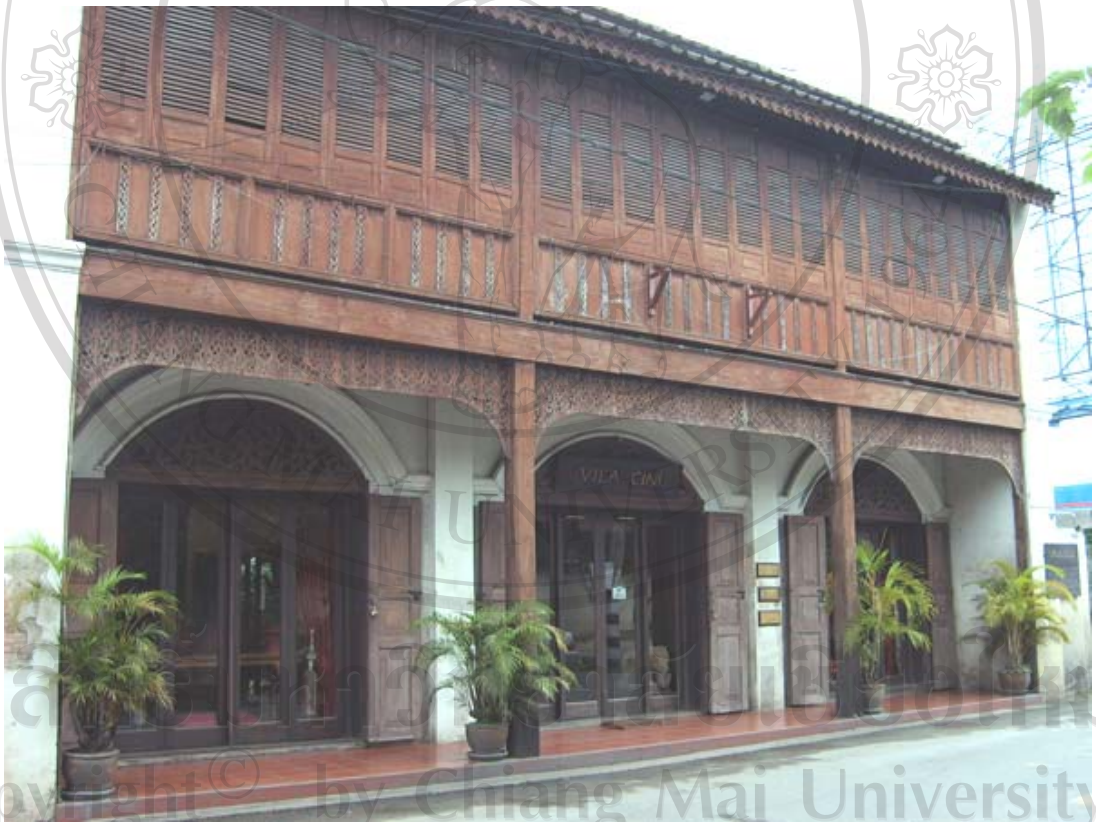
Fig.5.3 The selected 2-storey historic house in Wat Ket: **VILLA CINI** for applications.

The selected house, called Villa Cini, located on the west side of the Charoen Raj Road was built in Chinese style almost 140 years ago. It has two stories from the beginning: shop downstairs and living upstairs. Similar to *Tu Giac* houses, its roof with 2 sloping roofs and its timber floor on the 2nd level are supported by the load bearing walls surrounding, and the type of shutter window was applied at the front wall.

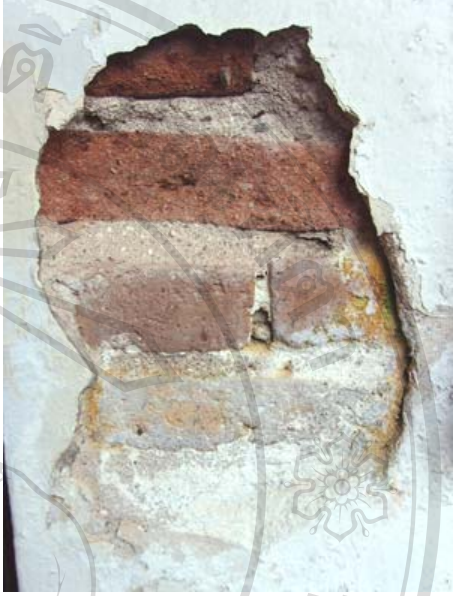
Destructions and Applicable conservation techniques	Photos
<p>Decayed plaster:</p> <ul style="list-style-type: none"> ▪ The flakiness of decayed plaster makes the bricks inside exposed to environment. <p>Conservation methods for application:</p> <ul style="list-style-type: none"> – P1 – P2

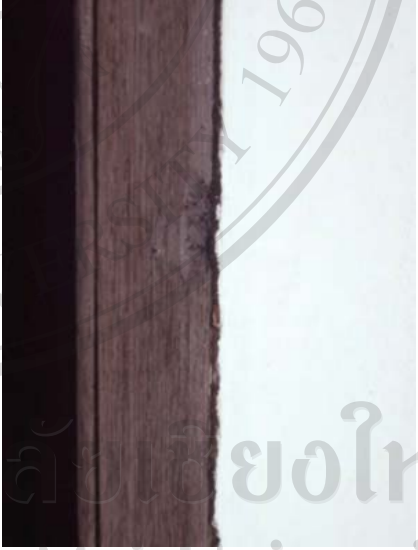
<p>Decays of timbers contacting masonry walls:</p> <ul style="list-style-type: none"> ▪ Rots of timbers caused by high moisture content from masonry walls and the fungi-attacks. <p>Conservation methods for application:</p> <ul style="list-style-type: none"> – T3

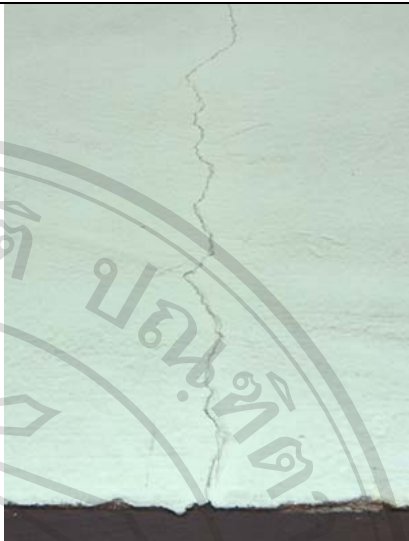
<p>Cracks of the load bearing walls:</p> <ul style="list-style-type: none"> ▪ Appear above the doors due to the overload of the wall above and the weakness of wooden door-frame beneath. <p>Conservation methods for application:</p> <ul style="list-style-type: none"> – C2

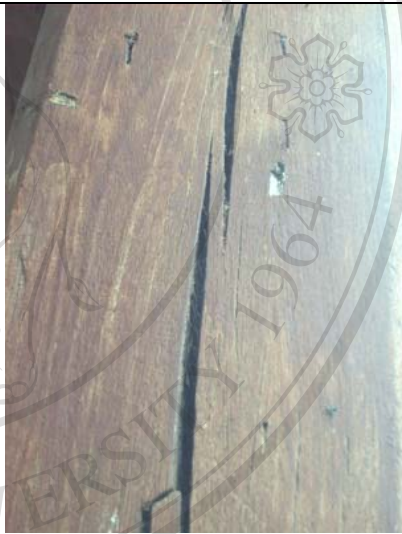
<p>Cracks on timber beams and pillars:</p> <ul style="list-style-type: none"> ▪ The thermal movement of wood materials due to changes of temperature and moisture content. <p>Conservation methods for application:</p> <ul style="list-style-type: none"> – T1 – T2

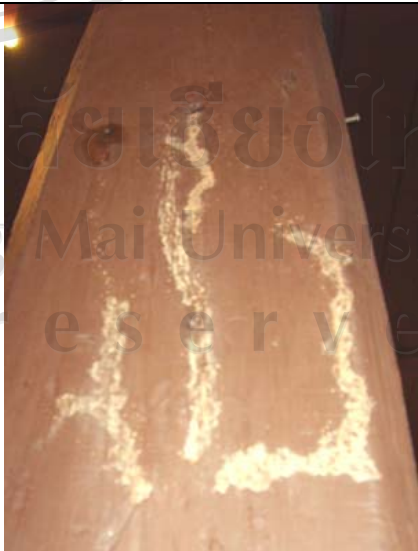
<p>Fungi attacks on timber elements:</p> <ul style="list-style-type: none"> ▪ Rots appear due to the high moisture content accompanied by the lack of fungal-resistant cover on wood surface. <p>Conservation methods for application:</p> <ul style="list-style-type: none"> – DP

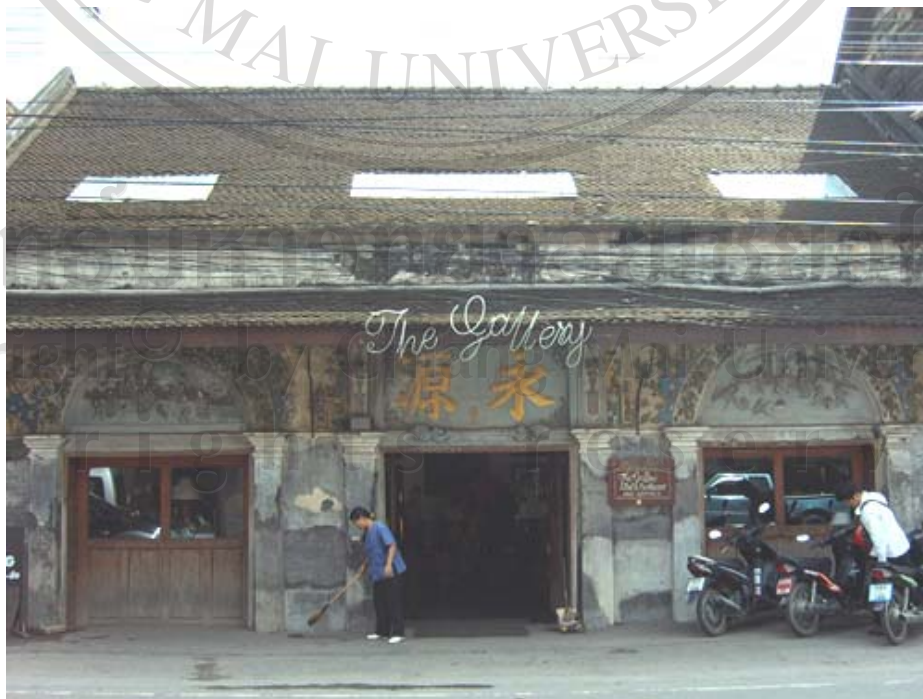
Fig.5.5 The selected 1-storey historic house in Wat-Ket: The Gallery for applications.

The house (*address: 25-27-29 Charoen Raj Road*) lies on the land-strip between the street and the river, facing the street frontward and the river backward which has the same geographical situation of *Tu Giac* houses. The house currently housing the Gallery was built in 1892 by the grandfather of the owner, one of Chinese immigrants in Chiang Mai at that time. The house is divided into two parts separated by a courtyard: the front building was constructed in traditional Chinese style in stucco with molded motifs and 2 sloping roofs along the length of the building, and the rear structure was built of teakwood following the Northern style of Thailand. The front building which contains some similar characteristics of *Tu Giac* houses like the load bearing walls and the timber floors or doors has been chosen for application.

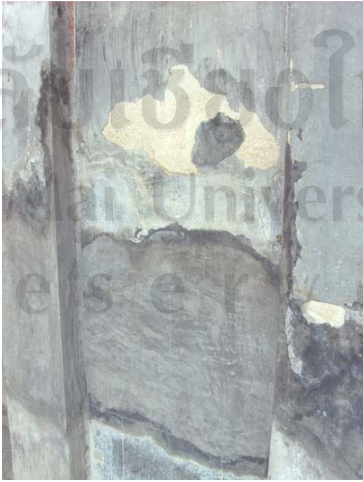
Destructions and Applicable conservation techniques	Photos
<p>Decayed plaster:</p> <ul style="list-style-type: none"> ▪ The flakiness of decayed plaster which was made from stucco and solid bricks. ▪ The incorrect ways of repairing by plastering new mortar unfitting the old one. <p>Conservation methods for application:</p> <ul style="list-style-type: none"> – P1 – P2

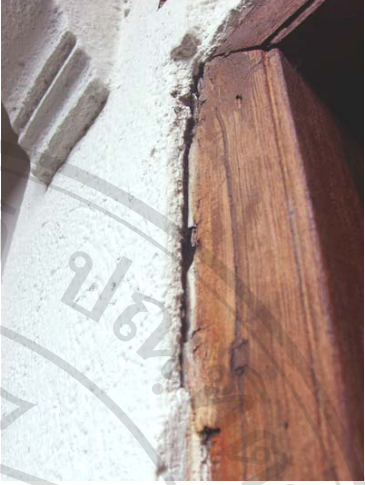
<p>Decays of timbers contacting masonry walls:</p> <ul style="list-style-type: none"> ▪ Rots caused by high moisture content from masonry walls and the fungi- attacks. <p>Conservation methods for application:</p> <p>– T3</p>

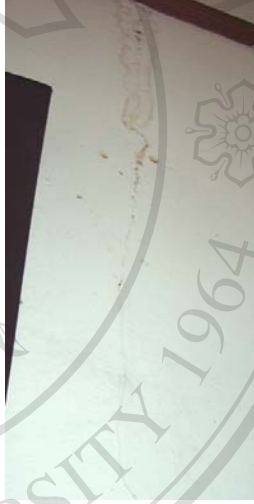
<p>Cracks of the load bearing walls:</p> <ul style="list-style-type: none"> ▪ Cracks appear in the plaster under the endpoints of timber beams of the roof where roof-load is transferred downward. <p>Conservation methods for application:</p> <p>– C2</p>

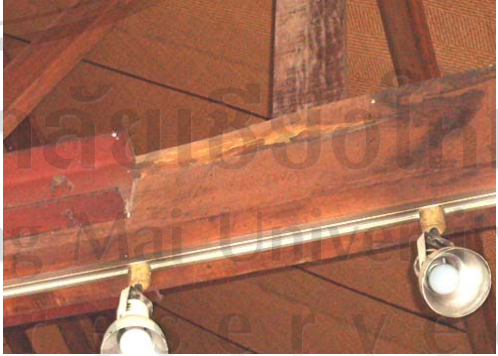
<p>Cracks on timber beams:</p> <ul style="list-style-type: none"> ▪ The overload of the roof causes cracks on the timber beams. ▪ The incorrect way of using the steel beams for consolidation makes the structure heavier and leads to the reduction of authenticity. <p>Conservation methods for application:</p> <p>– T1</p> <p>– T2</p>

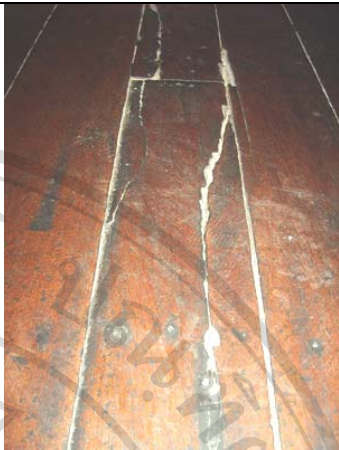
<p>Cracks on timber planks of the floor:</p> <ul style="list-style-type: none"> ▪ Cracks appear due to thermal movement of wood material caused by the change of temperature and moisture content. <p>Conservation methods for application:</p> <p>– T2</p>
